Illinois Commerce Commission
Assessment of
Central Illinois Light Company's
Annual Reliability Report and
Electric Service Reliability
For Calendar Year 2008

Pursuant to 83 Ill. Adm. Code 411.140

December 22, 2009

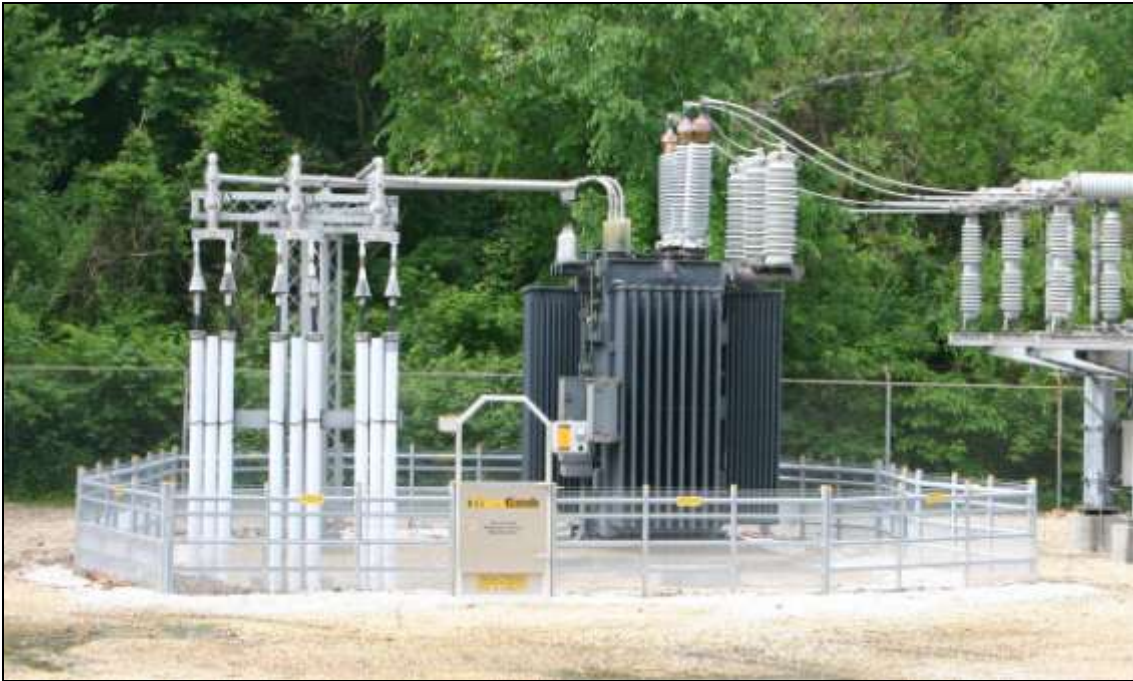
When inspecting Circuit D87-001, Staff noted that AmerenCILCO had installed an impressive electrified animal fence around its distribution equipment inside the

Photo 1: Additional animal fence surrounds distribution equipment inside substation.

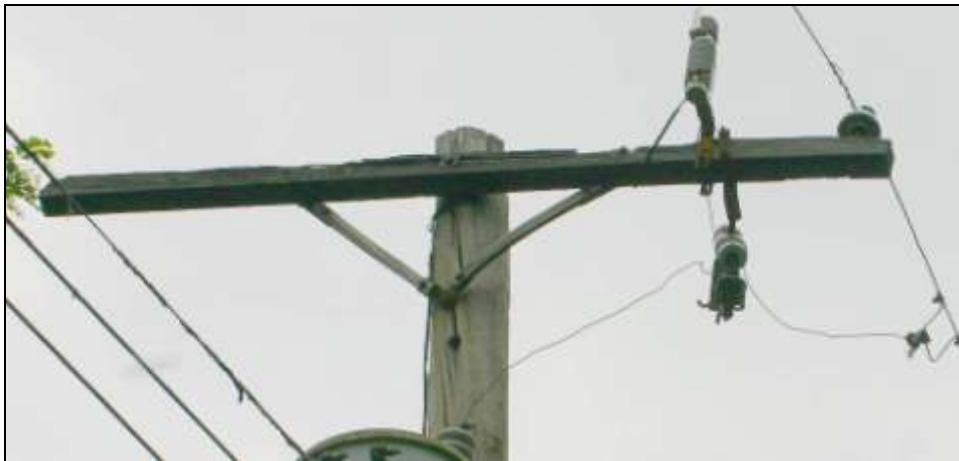
Photo 2: Cross arm base twisted away from pole with top deteriorated down to bolts (D87-001)

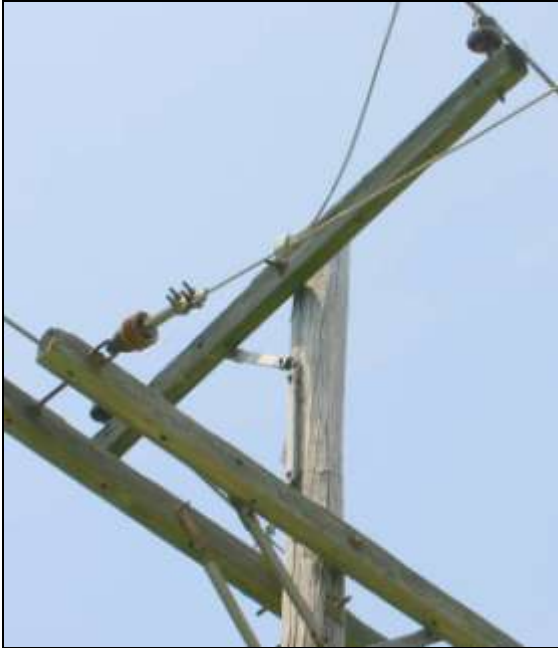
Photo 3: Detached brace, and nut missing from insulator pin. (D87-001)

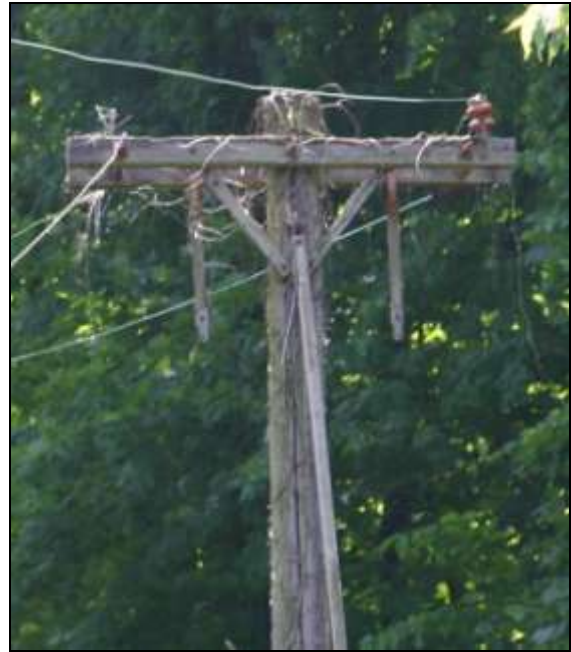
Photo 4: Two disconnected braces on double arm (D87-001)

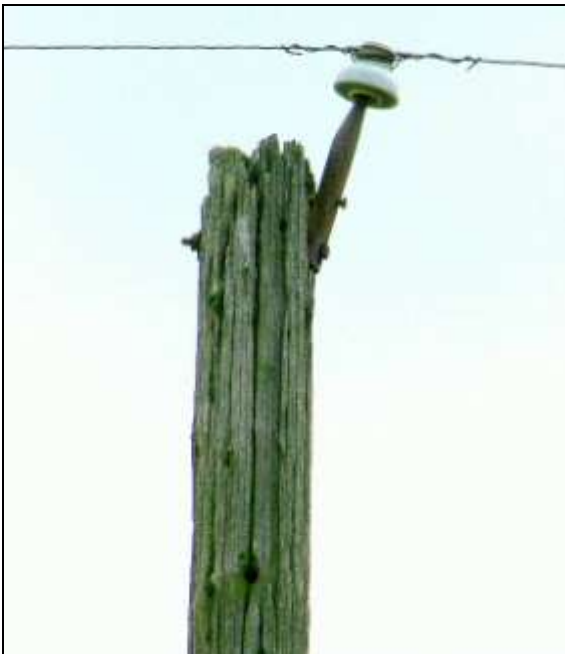
Photo 5: Deteriorated pole top with insulator pin coming loose (D87-001)

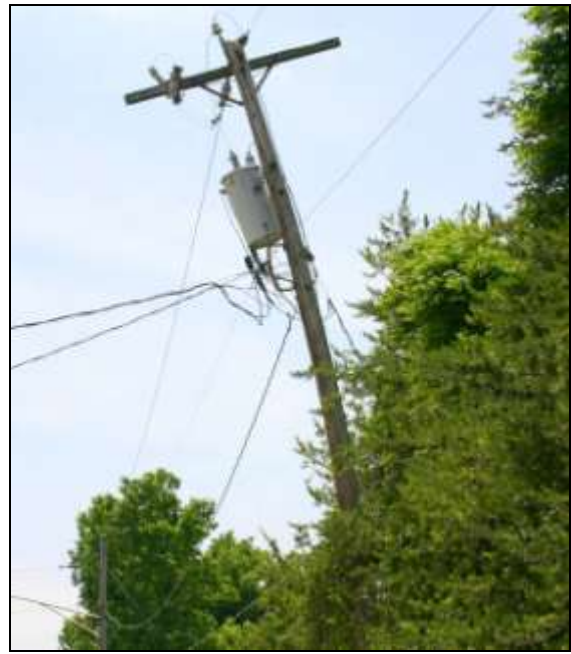
Photo 6: Pole with oil-filled transformer leaning over on hillside. (D87-001)

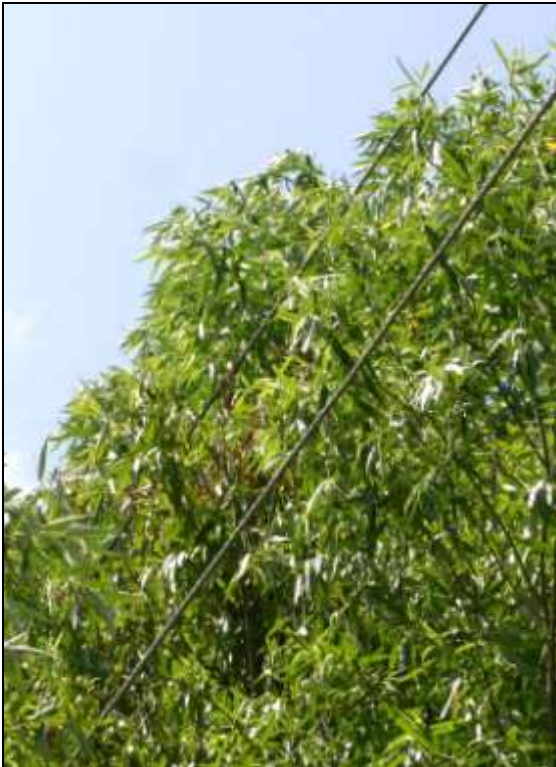
substation perimeter fence (Photo 1). Out on the distribution circuit, Staff observed a number of reliability concerns, including several locations where conductor clearances over the ground did not comply with National Electrical Safety Code ("NESC") requirements. Additional facility issues that Staff noted included deteriorated cross arms and/or deteriorated or detached braces at 4 locations (Photo 2-4), deteriorated pole tops at 8 locations (Photo 5), leaning poles at 4 locations (Photo 6), damaged ground wires at 3 locations, a blown lightning arrester, and 21 locations where vegetation was either contacting or very close to primary conductors (Photos 7-8).

Photo 7: Tree grown through and around primary and neutral conductors. (D87-001)

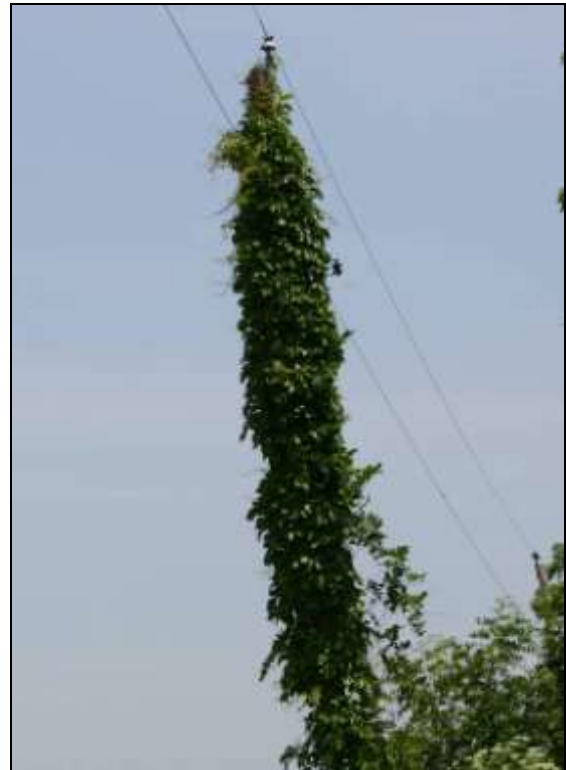
Photo 8: Vines grown up pole to primary. (D87-001)

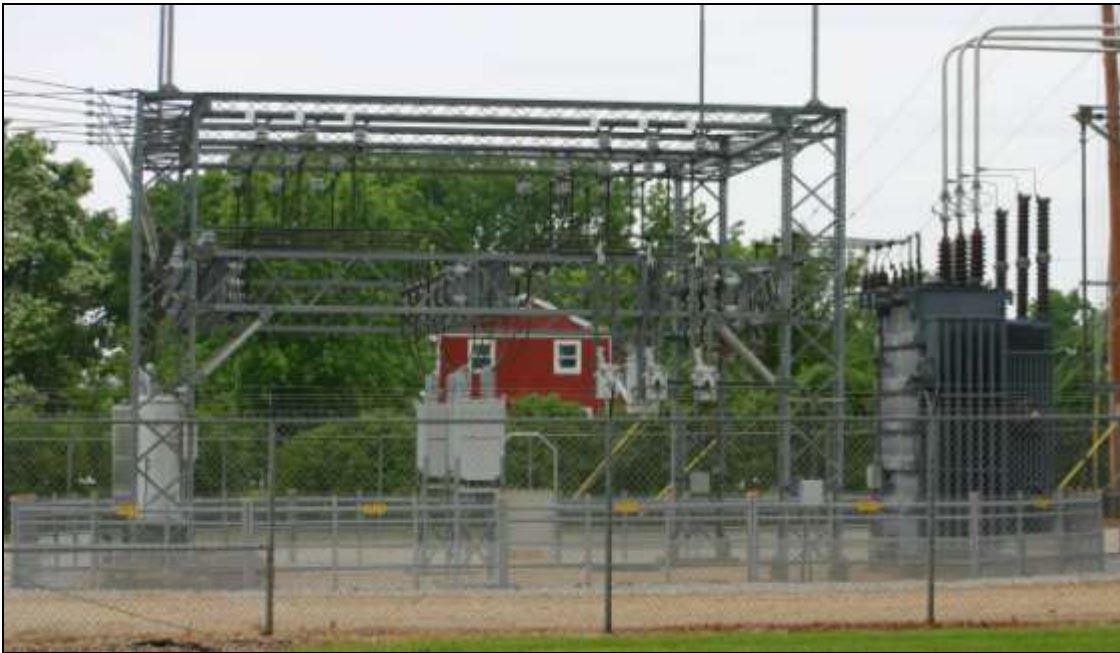
Photo 9: AmerenCILCO's Cornell Substation's animal fence (Supplies Circuit C00-001)

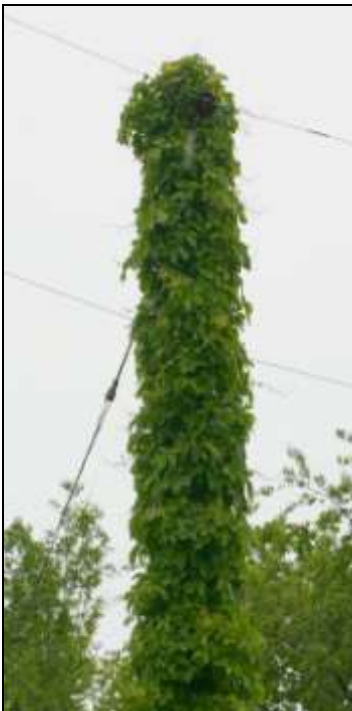
Photo 10: Vines grown to top of pole (C00-001)

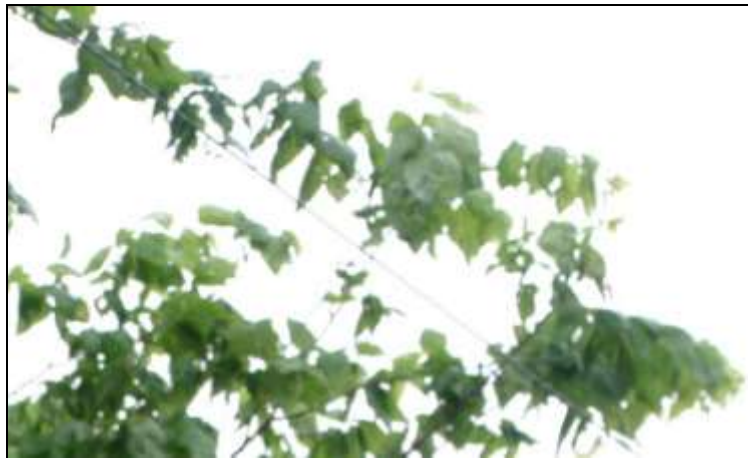
Photo 11: New tree growth blowing into primary conductor (C00-001)

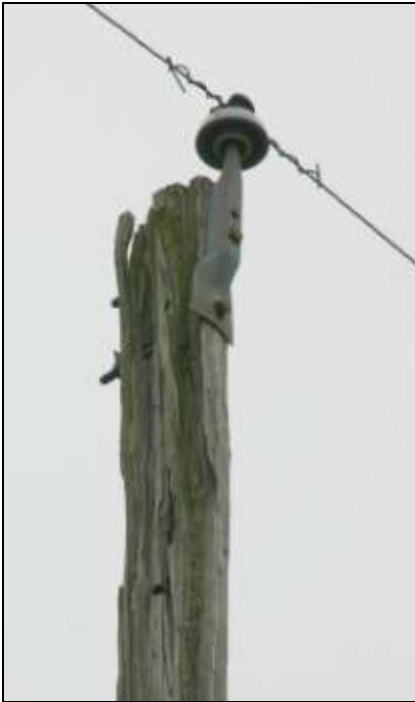
Photo 12: Deteriorated, splitting pole top (C00-001)

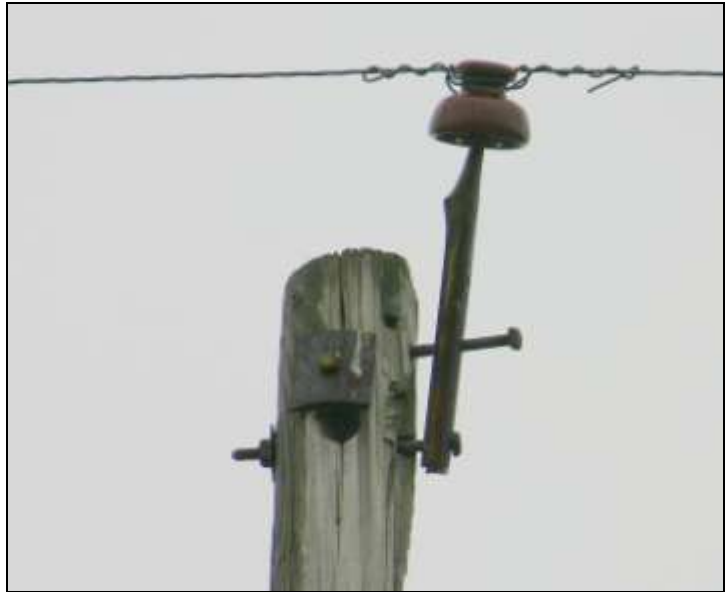
Photo 13: Woodpecker hole at loose lower bolt of pole top pin, while upper bolt is nearly out of pole (C00-001)

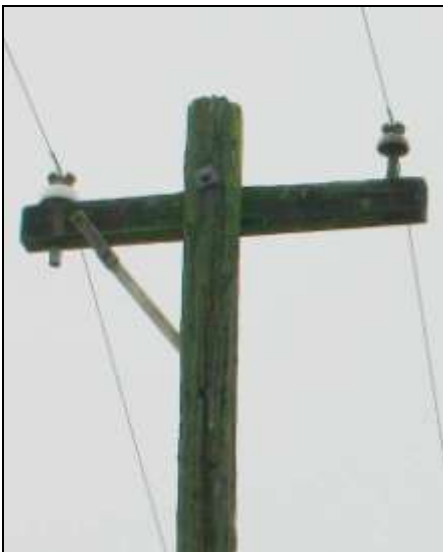
Photo 14: Missing brace with wooden primary insulator pin fallen through arm (C00-001)

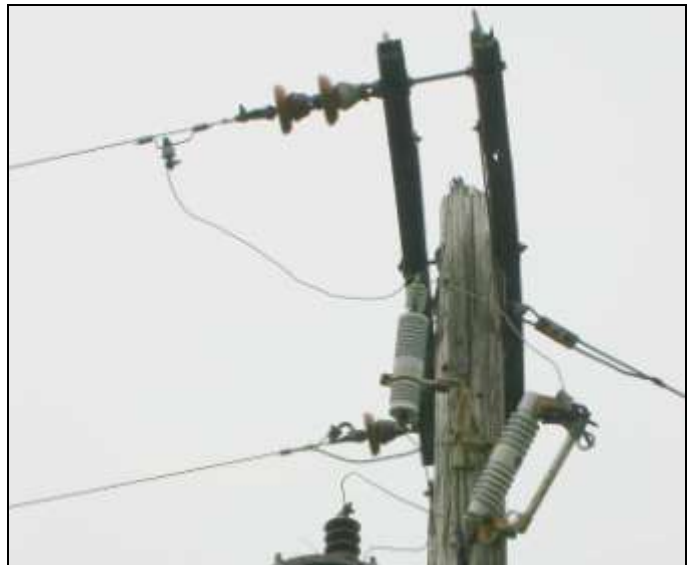
Photo 15: Deteriorated double arm with bolt attaching arms to pole coming loose (C00-001)

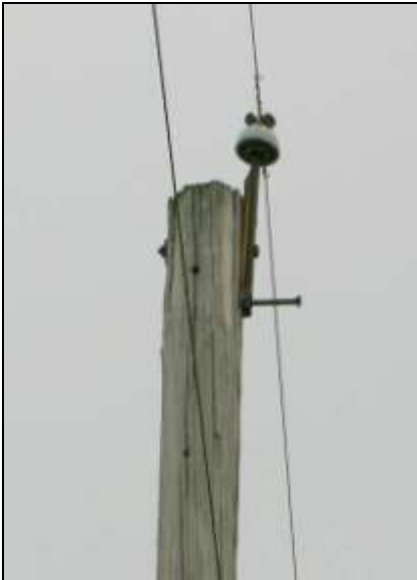
Photo 16: Bottom bolt coming out of pole top pin (C00-001)

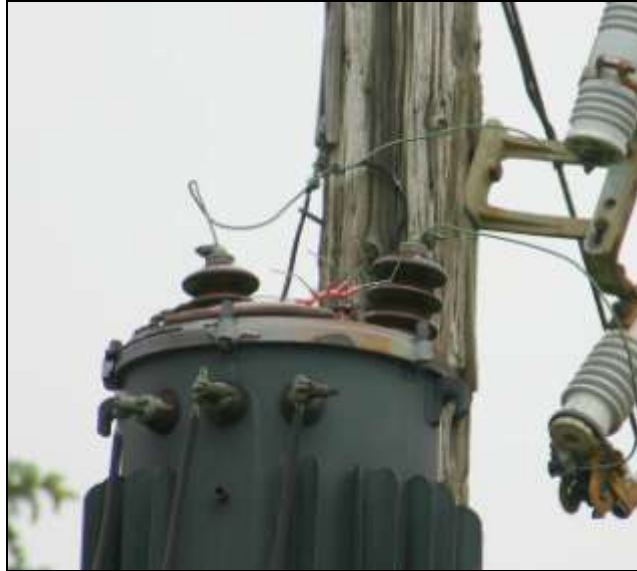
Staff observed that at AmerenCILCO's Cornell Substation, which is the source for Circuit C00-001, AmerenCILCO had again installed an electrified animal fence around its distribution equipment inside the perimeter fence. The substation grounds appeared to be very well maintained (Photo 9). When inspecting Circuit C00-001, Staff observed nine locations where vegetation was contacting or growing close to the primary conductor (Photos 10-11). Other potential reliability threats that Staff observed included deteriorated poles at 21 locations (Photos 12-13), deteriorated cross arms and/or deteriorated or detached braces at 6 locations (Photo 14-15), and an NESC violation where a down guy was too low over a driveway. Staff also noted several locations where AmerenCILCO's hardware was loose or missing (Photos 13, 15-16), and a location where an animal guard was simply laying

Photo 17: Animal Guard setting between transformer bushings (C00-001)

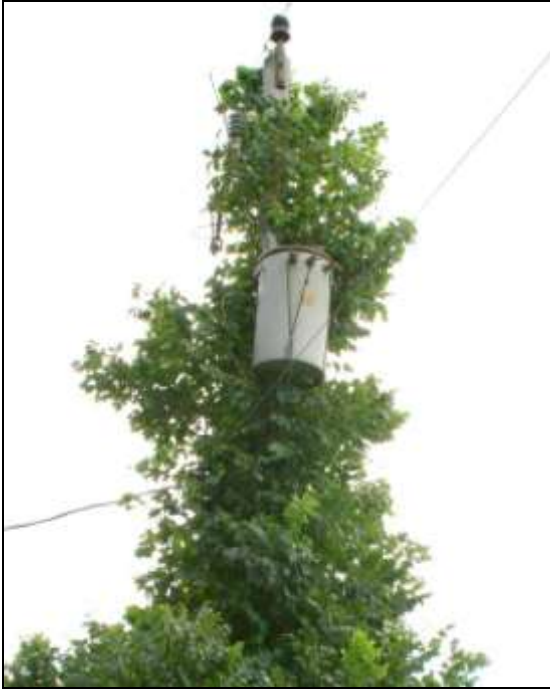
When inspecting Circuit C70-001 during August of 2009, Staff noted 53 locations where vegetation was contacting, or very close to, the primary conductor (Photos 18-19). In addition, Staff noted 10 locations where hardware was loose or missing (Photos 20-22), 11 locations where pole tops, arms, or braces were deteriorated and/or damaged (Photos 23-25), 7 locations where ground connections were broken or missing, 2 locations where poles were leaning rather severely, and 1 location with significant woodpecker damage to AmerenCILCO’s pole. Staff also noted one location where an animal guard had migrated up a jumper so that it was no longer effective (Photo 26), and 2 locations where AmerenCILCO’s map did not appear to reflect the location of its facilities in the field. Staff identified 5 NESC violations: three involving inadequate conductor height, and two involving improper framing at railroad crossings (Photo 27).

Photo 18: Vegetation completely covering pole to primary level (C70-001)

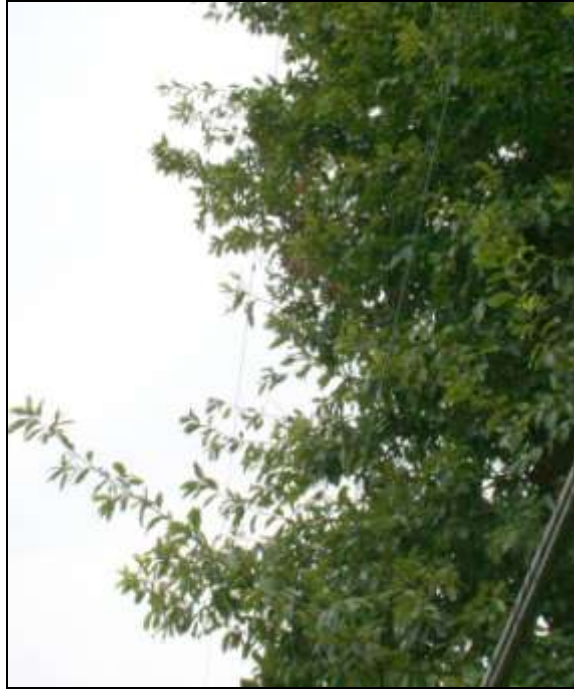
Photo 19: Tree growing between primary and neutral conductors (C70-001)

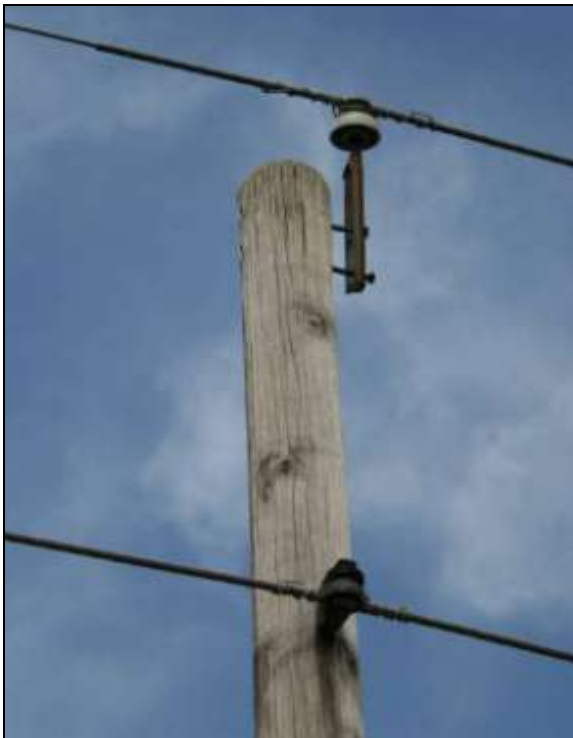
Photo 20: Both nuts missing from pole top pin bolts, and bolts coming out of pole (C70-001)

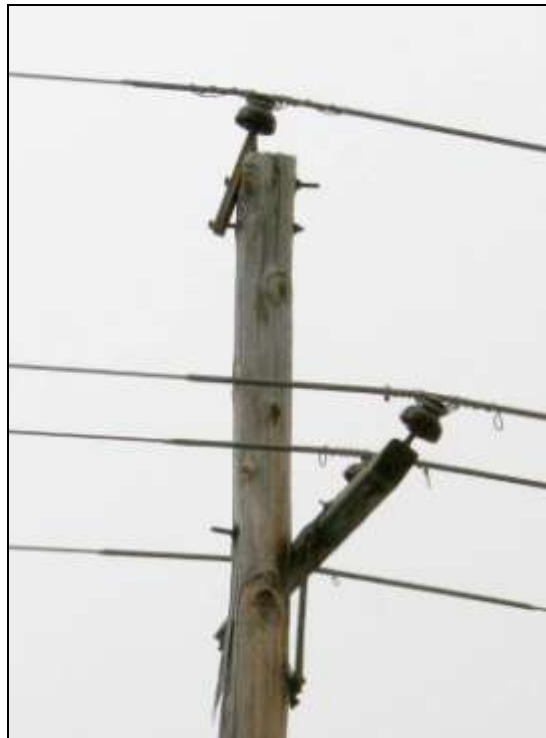
Photo 21: Bolts loose at pole top pin and cross arm (C70-001)

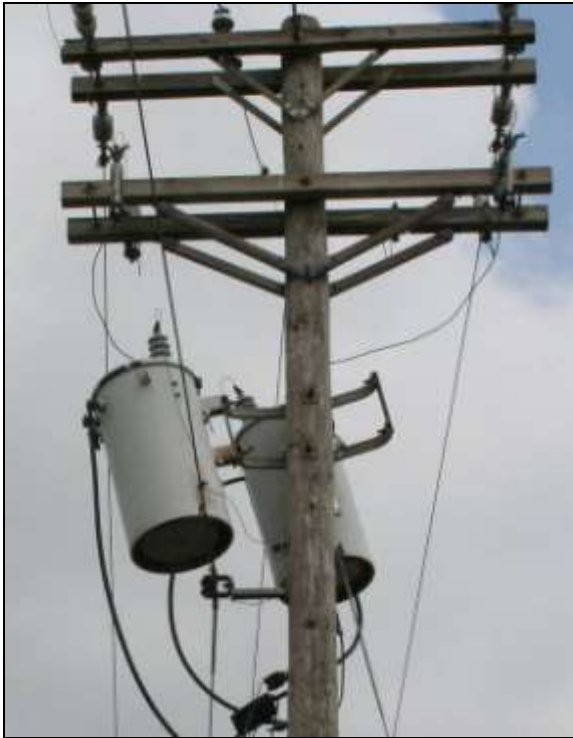
Photo 22: Transformer bracket appears to be coming loose from pole (C70-001)

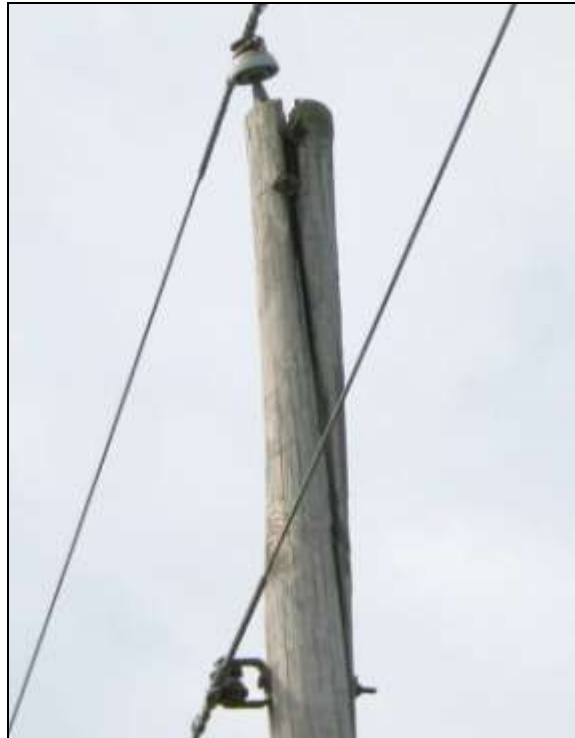
Photo 23: Top of pole splitting so that pole top pin is loose and leaning over (C70-001)

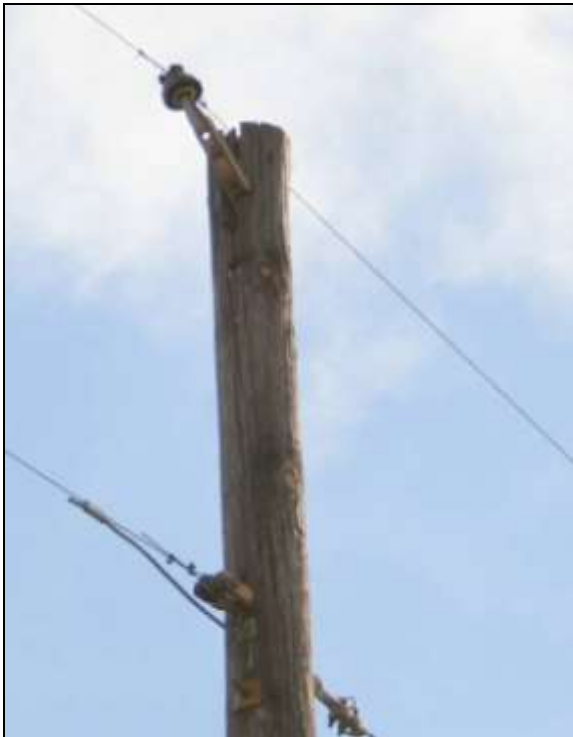
Photo 24: Splitting pole top causing pole top pin to lean over (C70-001)

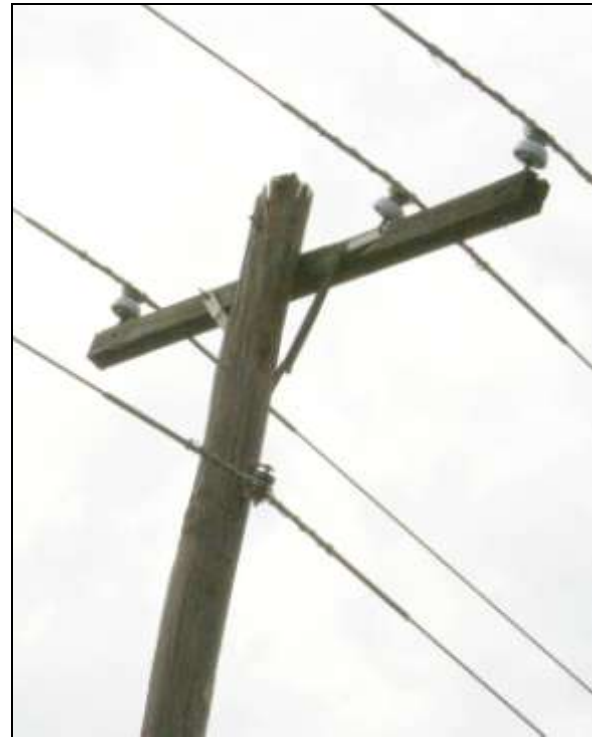
Photo 25: Deteriorated pole top, splitting arm, and broken cross arm brace (C70-001)

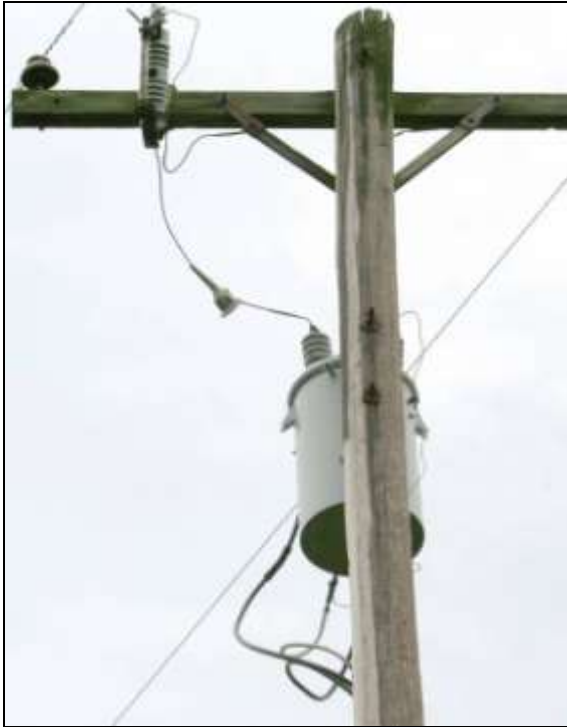
Photo 26 Animal guard appears to have slid up jumper so that it no longer covers transformer bushing (C70-001)

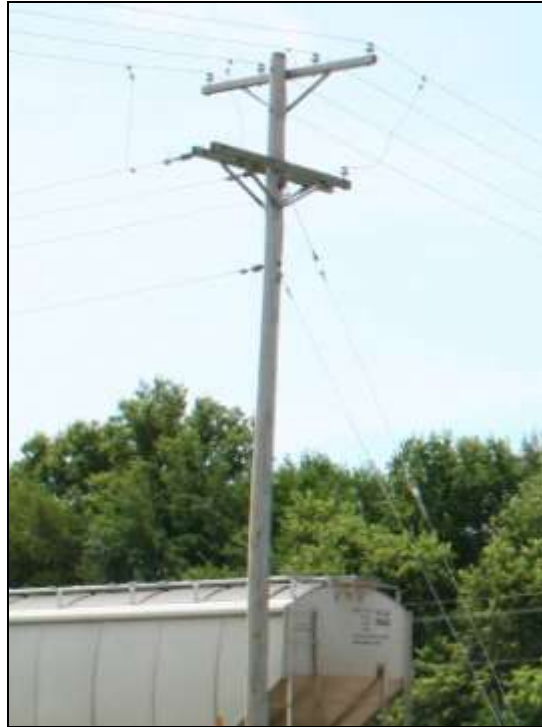
Photo 27: Single cross arm rather than double for top conductors where line crosses railroad (C70-001)
